INNOVATIVE MAGNESIA-CHROME FUSED GRAIN MATERIAL FOR NON-FERROUS METALS REFRACTORY APPLICATIONS

D. Gregurek	RHI AG, TC Leoben
T. Prietl	RHI AG
S.B. Breyner	RHI AG, TC Leoben
A. Ressler	RHI AG, TC Leoben
N.-M. Berghofer	RHI AG

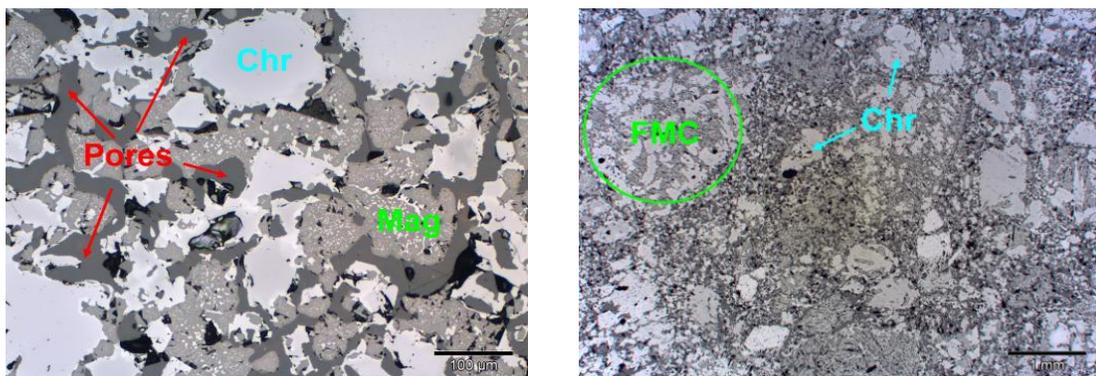
Figure 1-Microstrutural overview/detail. Microstructure of RADEX VFG with newly developed fused magnesia-chromre smelter (FMC) and chromite (Chr). Pores filled with preparation resin

The new magnesia-chromite brick RADEX VFG consists of newly-developed fused magnesia-chromite smelter material. Chrome ore (low in silica) was added additionally to increase the resistance to corrosion and thermal shock. The microstructure of the newly developed brick brand is presented in Figure 1.

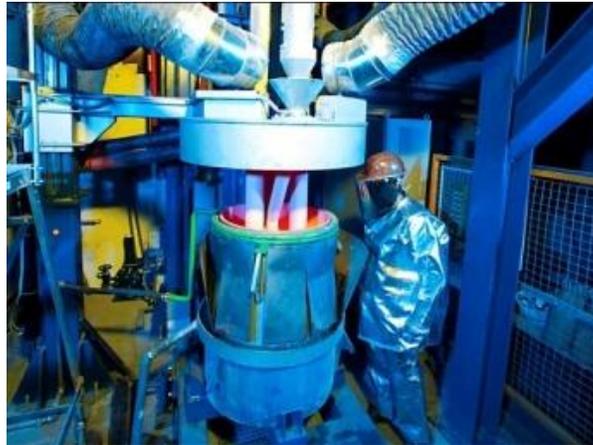
Figure 2- Raw material synthesis at TC Leoben

Figure 2 shows the smelter plant (pilot plant at the TCL) in which the fused magnesia-chromite material was produced. After positive chemical, physical and mineralogical material characterization of the first melting blocks (up to 400 kg) the RHI Radenthein plant started with industrial production of that material. The first successful brick production at the Radenthein smelter plant was completed in July 2011 after numerous laboratory and industrial scale trials.

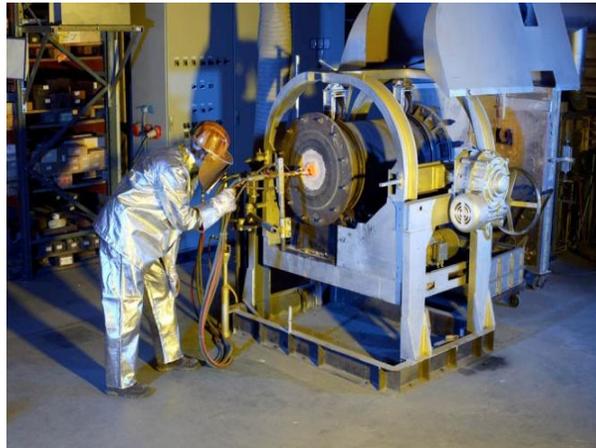
Figure 3-Rotary kiln test

The rotary furnace is relatively small (92 mm in diameter); however, up to six different brick brands can be installed and tested simultaneously (Figure 3). Trials are usually performed within a temperature range of 1400–1700°C. The furnace is heated using a propane-oxygen gas mixture. During the test, 3–5 kg of slag is used per cycle. The specific analysis described in this paper was carried out for 20 cycles at 1600°C. The rotation of the furnace also results in a dynamic testing procedure.

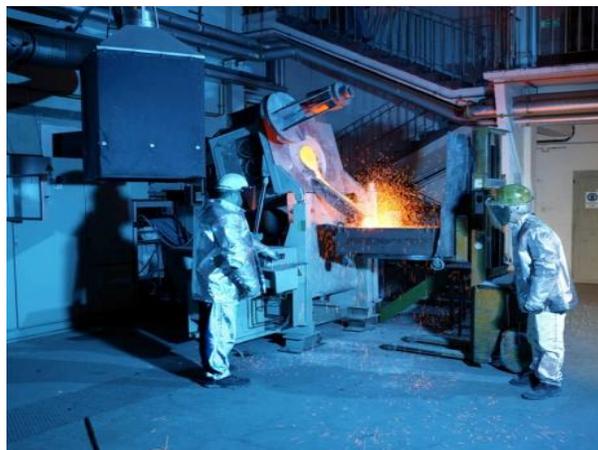
Figure 4-Induction furnace test

Up to 16 different grades can be used to line the induction furnace (Figure 4). The furnace is 250 mm in diameter and operates in a temperature range of 1500°C to 1750°C (1650°C for the tests described). During the practical test, up to 60 kg of metal and 1.5–2 kg slag are used per cycle, and the slag is changed every 0.5–1.5 hours. The test described here was run for approximately 6 hours.

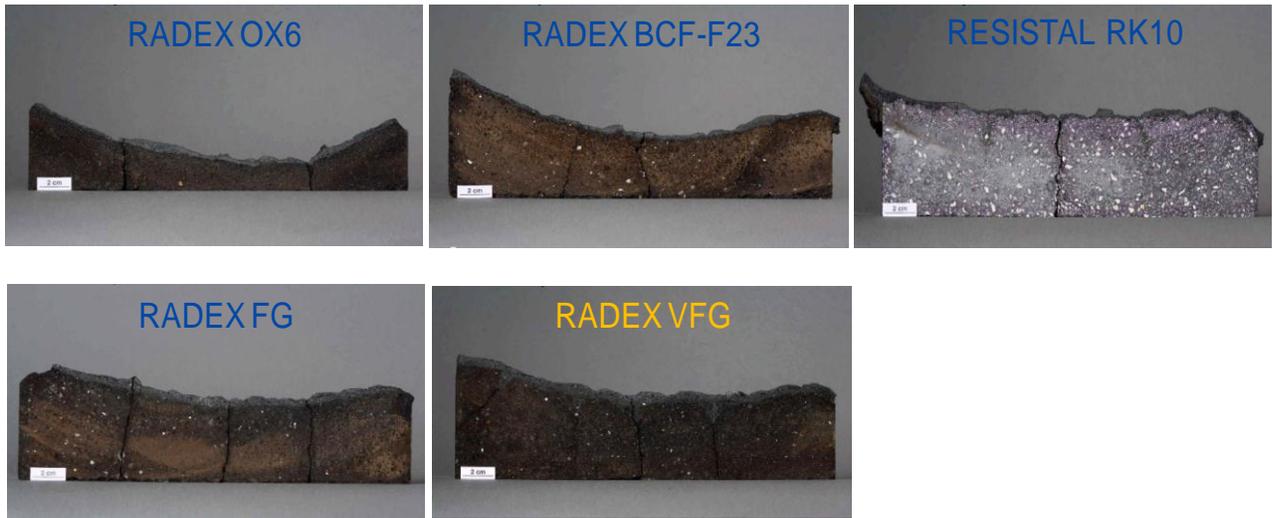
Figure 5-Magnesia-chromite RADEX OX6, RADEX BCF-F23, RADEX FG, RADEX VFG, and alumina-chromia RESISTAL RK10 bricks after the rotary kiln test

The macroscopic overviews of all the tested bricks, in cross section, are shown in Figures 5 and 6. Table II summarizes the results of both trials, including the evaluation of the wear area/depth in terms of the final cross-sectional profile. The mineralogical investigations were performed on polished sections using a reflected light microscope and a scanning electron microscope combined with an energy-dispersive X-ray analyser (Figures 7 to 9).

According to the macroscopic appearance (cross-sections), the best performing bricks, in terms of the wear area and wear depth, were RADEX VFG and the alumina-chromia brick RESISTAL RK10. The highest wear was observed for RADEX OX6.

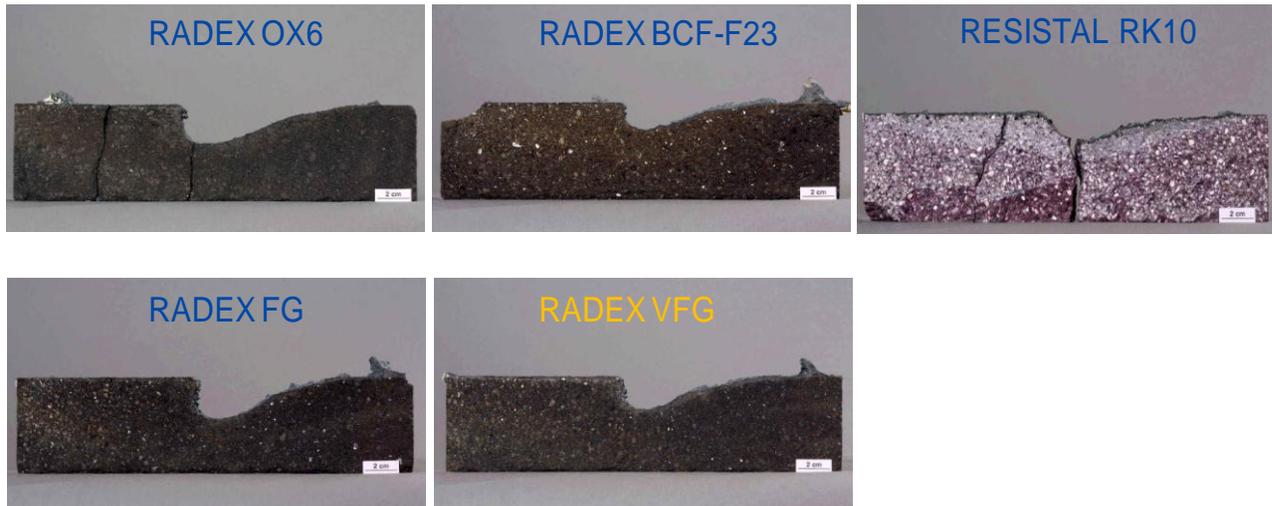
Figure 6-Magnesia-chromite RADEX OX6, RADEX BCF-F23, RADEX FG, RADEX VFG, and alumina-chromia RESISTAL RK10 bricks after the induction furnace test

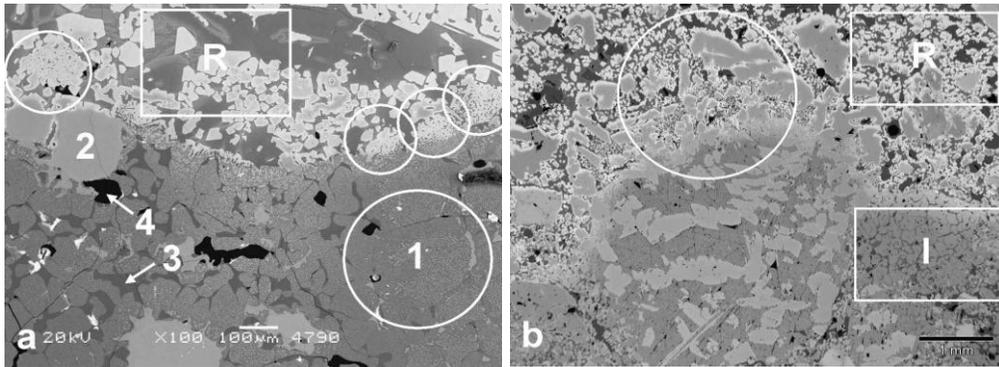
Figure 7-Microstructural overview/detail, immediate brick hot face. (a) RADEX OX6, (b) RADEX VFG. Reaction layer (R), infiltrated and corroded brick microstructure (I), relics of chromite precipitations (circles) after the corrosion and dissolution of magnesia within the OXICROM sinter (1), chromite (2), forsterite (3), pore (4)

The immediate brick hot face was covered with a thin reaction zone of 3–5 mm. Behind the reaction zone, an infiltrated and corroded brick microstructure could be observed. The infiltration depth varied between 2–17 mm. The lowest infiltration of the brick microstructure was exhibited by RADEX VFG and RADEX FG (approximately 3 mm). The highest infiltration depth was observed for RADEX OX6 (up to 17 mm), which showed complete infiltration over the entire polished section.

At the transition between the reaction zone and the infiltrated brick microstructure there was dissolution of the magnesia brick component, leaving relics of primary and secondary chromite precipitations. Due to diffusion phenomena, the chemical composition of the chromite was also altered, becoming enriched with mainly Fe-oxide at the rims. This was also observed for primary and secondary chromite precipitations.

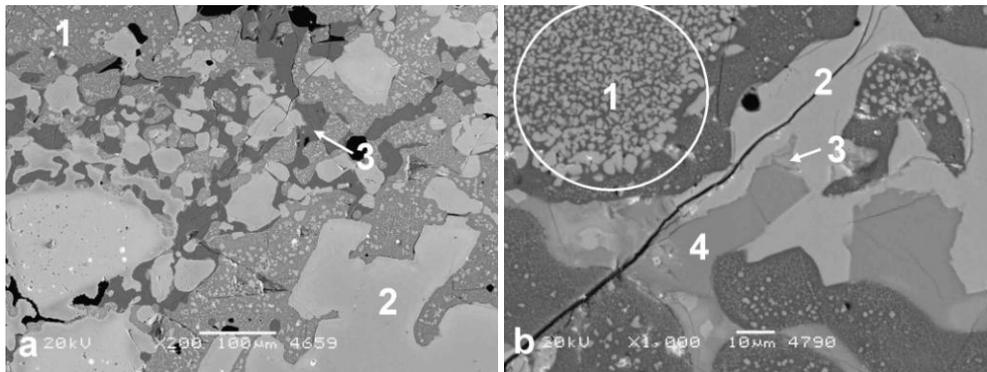
Figure 8-(a) RADEX VFG, microstructural detail, approx. 1 mm from the brick hot face. Infiltrated and corroded brick microstructure. Fused MgCr-grain (1), chromite (2), forsterite (3). (b) RADEX OX6. Microstructural detail, approx. 20 mm from hot face. OXICROM sinter (1), chromite (2), corrosion of the interstitial phase dicalcium silicate (C_2S) (3), merwinite (4)

In the infiltrated brick microstructure, due to corrosion of the magnesia brick component, the main reaction product was Mg-silicate forsterite (Mg_2Si). In addition, the interstitial phase of the magnesia component, especially the dicalcium silicate (C_2S), was corroded. The main reaction product was monticellite (CMS).

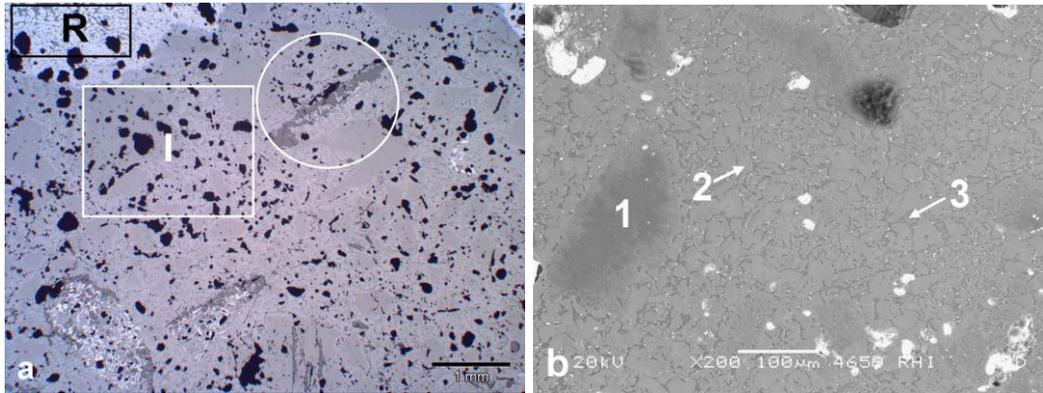
Figure 9-(a) Microstructural overview, immediate hot face. (b) Microstructural detail, approx. 5 mm from hot face. Reaction layer (R), infiltrated and degenerated brick microstructure (I), corroded Zr-mullite (circle), white fused alumina (1), Cr-corundum (2), phosphorus-bearing glassy phase (3)

The alumina-chromia RESISTAL RK10 brick showed an infiltration depth of approximately 5–10 mm. At the transition between the reaction zone and the infiltrated brick microstructure, fused alumina Mg-Fe-Al-Cr-oxide was formed due to corrosion of the main brick component. In the infiltrated brick microstructure the second main brick component, namely Zr-mullite, was also corroded. Within the infiltrated brick area the Cr-corundum bearing matrix had recrystallized.
